The quality of marine fuels and the safety of navigation: case studies

Włodzimierz Kamiński¹, Paweł Krause¹✉, Dariusz Gumiński², Przemysław Rajewski¹

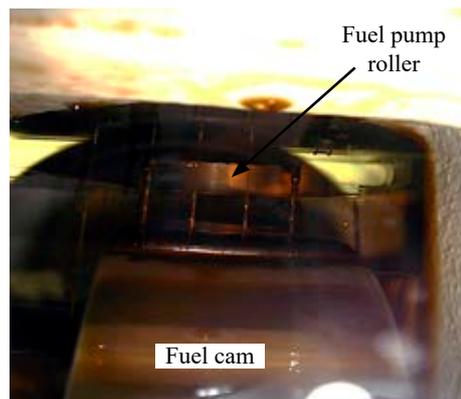
On July 16th, 2006 at 03.30 the engine monitoring system registered a large (over 50 degrees) deviation of the temperature of exhaust gases from cylinder No. 1. The chief engineer inspected the engine and found that the injection pump of the ME No. 1 unit did not supply fuel to the cylinder. Observation through the transparent cover of the camshaft revealed that the roller was not resting on the fuel

Figure 1. Suspended drive roller of the fuel pump

cam. The injection pump plunger remained in the upper position in the pump cylinder. Figure 1 presents a photo of the suspended drive roller. At 03.40 ME was stopped to replace components of the defective injection pump in ME No. 1 unit and identify the cause of pump failure. The ship was drifting. After dismantling the pump and removing the plunger and barrel from the pump body, the identified defects included plunger seizure, suspension of suction-delivery valve and overflow valve.

Additional analysis of fuel made after the accident showed chemical contaminations (polymethacrylates) in the fuel, which, among others, were responsible for the TSP value of 0.19%. At the high temperature required to achieve the desired fuel viscosity before the fuel injectors, approximately 135°C, these compounds settled on the injection pump barrel walls, hindering heat exchange between the barrel and the plunger of the injection pump and locally raising the temperature. This process adversely affected lubrication, reducing the plunger-barrel clearance (due to different thermal expansion of the components), and caused seizures due to the coagulating sediments of hard particles.

and jamming of the mating elements. The injection pump of the piston-crank unit was reassembled using new spare parts: a plunger-barrel unit, suction valve, overflow valve, plus a new set of sealings.

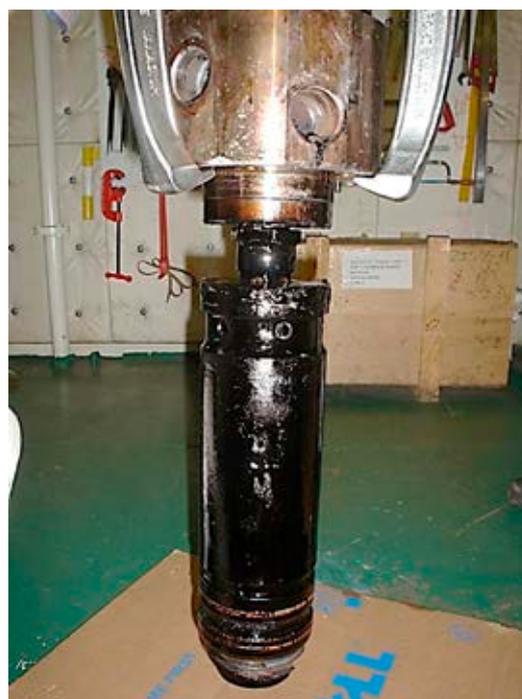
All internal components of the pump were covered with a layer of sediments that, under high temperature, had sustained carbonization. Figures 2 and 3 show photographs of injection pump elements after failure. Dismantling the injection pump was difficult because of hard deposits that caused seizure

Figure 2. Dismantled barrel of fuel pump, unit No. 1 after failure

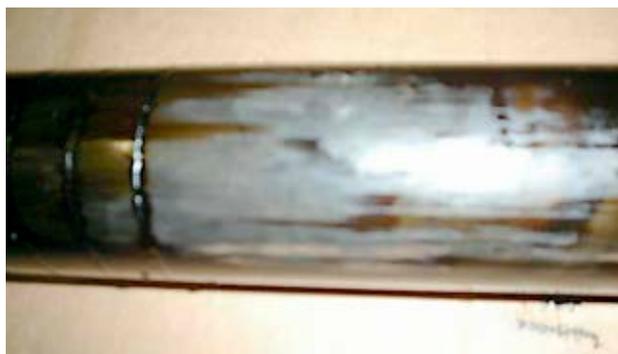
Figure 3. Traces of seizure on the fuel pump plunger, No. 1 unit after failure
