Microstructural aspects of repairing unalloyed cast steel with around 0.3% carbon content using welding technology

Abstract

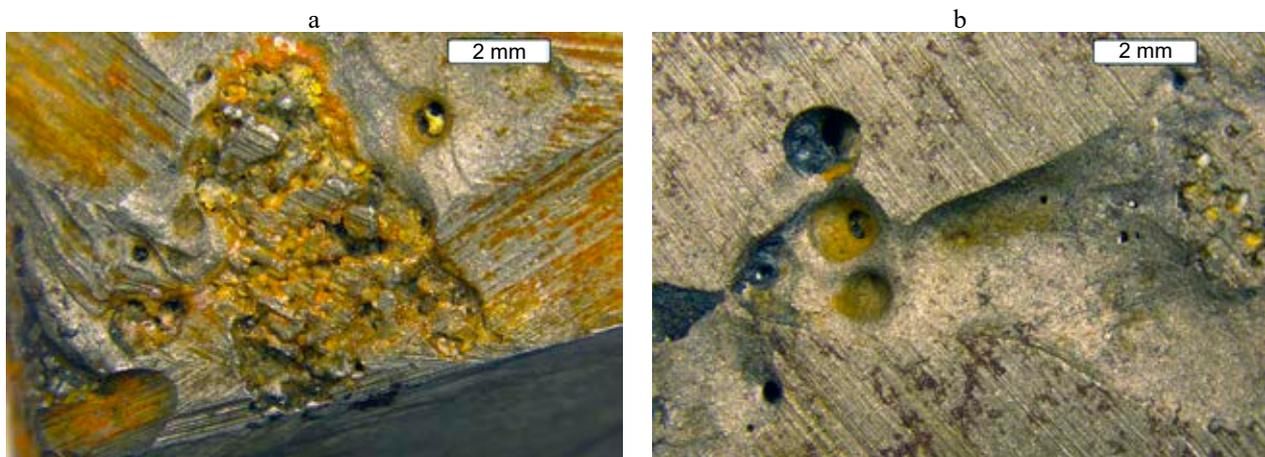
As a result of the macroscopic observations of the casting surfaces, the appearance of numerous casting defects and surface discontinuities in the form of open blowholes was found, as well as partial melts created as a result of the padding repair to the casting (Figure 1).

Figure 1. Stereoscopic image of the surface defects in the tested casting. Blowholes open to the surface and morphology indicating padding of the cast

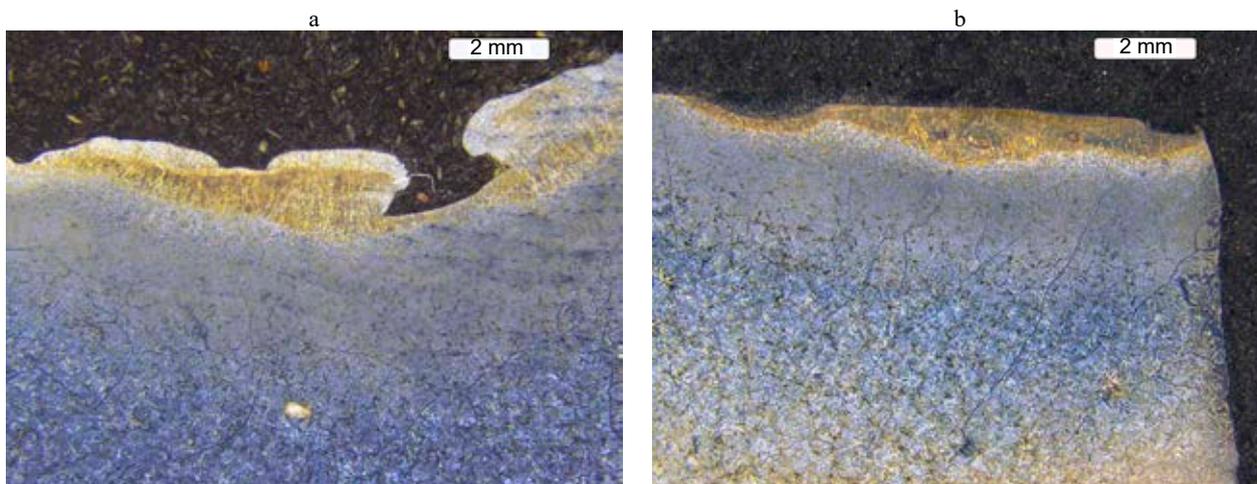
Figure 2. Stereoscopic images of the metallographic macrosections performed in location 1 (a) and 2 (b). Visible padding at surface of the casting: Etched state

The macrosection observations confirmed the occurrence of padding in the tested locations; their macrostructure is shown in Figure 2.

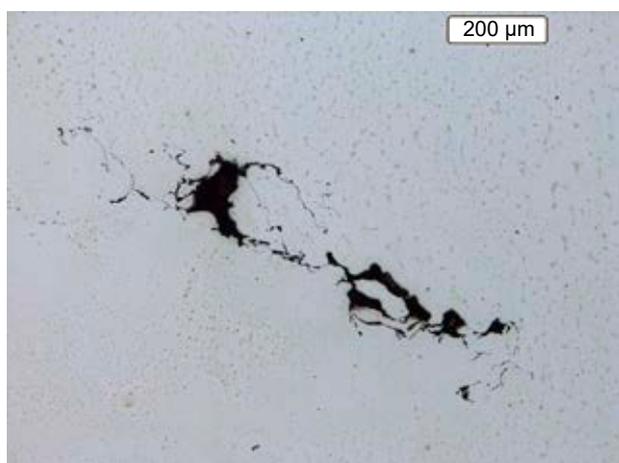
The microscopic observations of the core material of the tested casting in the non-etched state have shown the occurrence of a large number of fine globular non-metallic inclusions. In addition, numerous near-surface casting defects, both open and closed, were revealed (Figure 3). In the core material, the appearance of ferritic – pearlitic microstructure of Widmanstätten morphology was found (Figure 4). This microstructure of the tested component is indicative of its coarse-grained structure, as well as that it was not subjected to the normalizing operation.

Figure 3. Microstructure of the material in the non-etched state. There are visible surface defects and globular non-metallic inclusions in the casting material: Taken with light microscopy

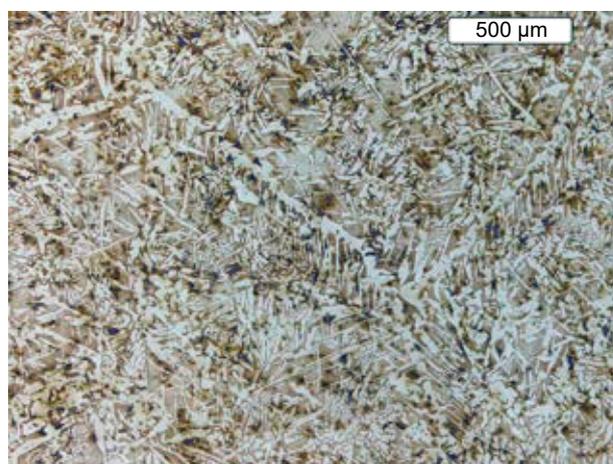
Figure 4. Microstructure of the tested casting core. The ferritic – pearlitic microstructure of Widmanstätten morphology is visible: Etched state

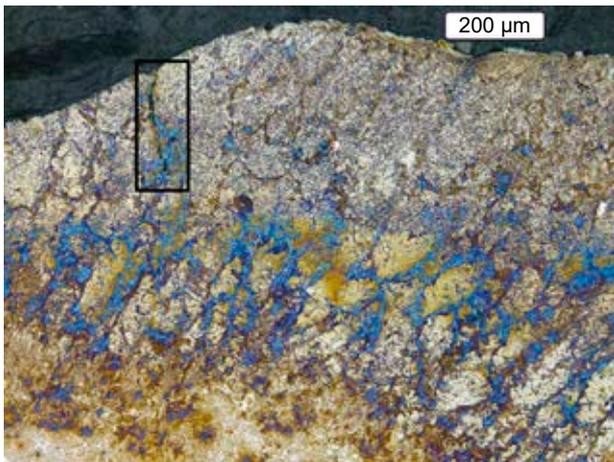
Figure 5. The near-surface microstructure of the tested casting in location 1. The visible disparity in the microstructure of the material and a crack propagating over the grain boundaries are marked with a frame; Etched state

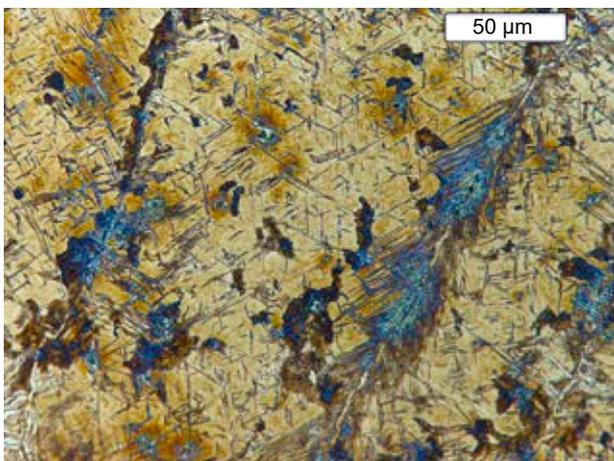
Figure 6. The microstructure of the padding in location 1: Magnified fragment of the area from Figure 5. There is visible martensite with a lot of residual austenite and locally appearing feathery bainite: Etched state

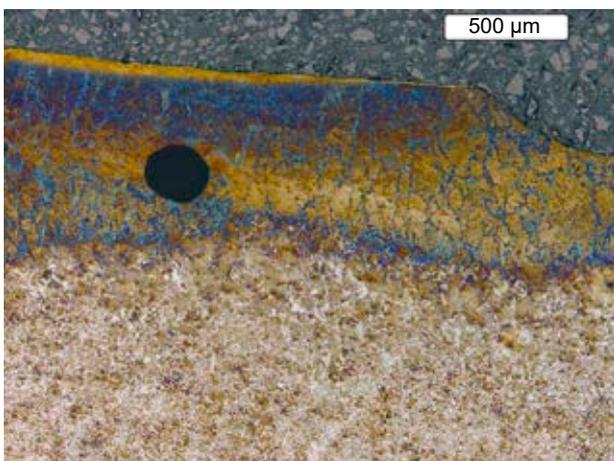
Figure 7. The near-surface microstructure of the tested casting in location 2. There are visible micropores and disparity of the microstructure of the material: Etched state

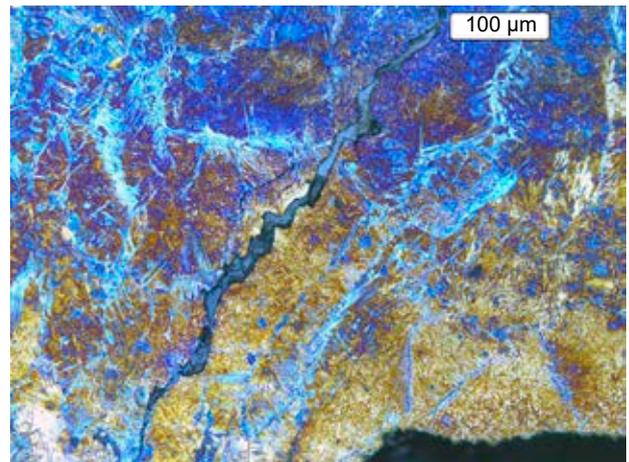
Figure 8. The microstructure of the padding in location 2. There is a visible crack running over the grain boundaries of the former austenite and the microstructure of the coarse-acicular martensite with feathery bainite: Etched state

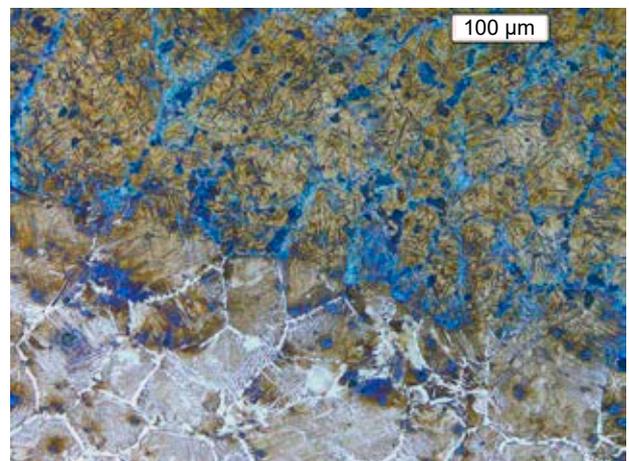
Figure 9. The microstructure of the padding in location 2 showing the transition zone between the padding and the native material. There is visible coarse-acicular martensite with feathery bainite in the area of the padding and the ferritic – pearlitic microstructure in the area of the padding and the microstructure with Widmanstätten structure features in the native material: Etched state

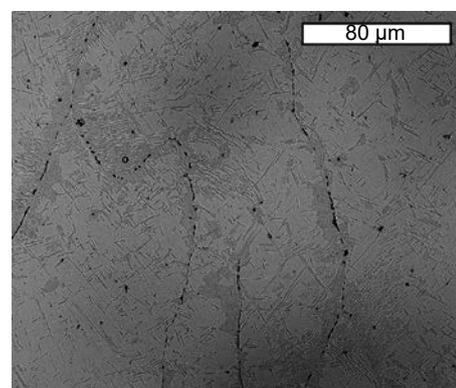
zone, a coarse-acicular martensite characteristic, for structures created as a result of the martensitic transformation from coarse-grained austenite, was observed. Locally, areas of feathery upper bainite areas were also observed which showed very high brittleness because of the easy nucleation of cracks in the large carbides that precipitated between the ferrite slats. Such a morphologically adverse microstructure led to the creation of numerous cracks during padding (Figures 5–9). The creation of the cracks was also favored by the appearance of continuous sulphide separations over the grain boundaries of the former austenite that was observed in the microscopic tests accomplished with the use of scanning electron microscopy methods. This type of precipitation is created in the case of the appearance of iron sulphides with a low melting point and they contributed to the creation of hot cracks in the cast steel (Figures 10 and 11).

Figure 10. SEM image of the padding in location 1. There is visible precipitation of iron sulfides on the grain boundaries of the former austenite. There are precipitations of manganese sulfides inside the grains: Etched state

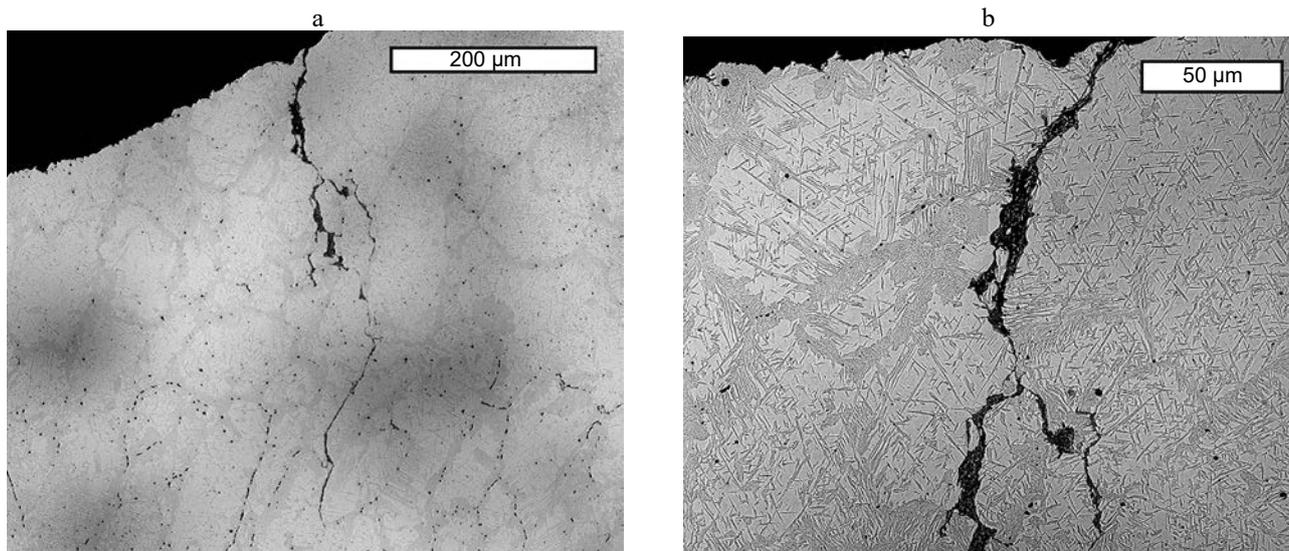
Figure 11. a) SEM microscopic image of the padding in location 1. There are visible non-metallic inclusions and a crack running over the grain boundaries of the former austenite. b) Magnified fragment of the area in image (a)

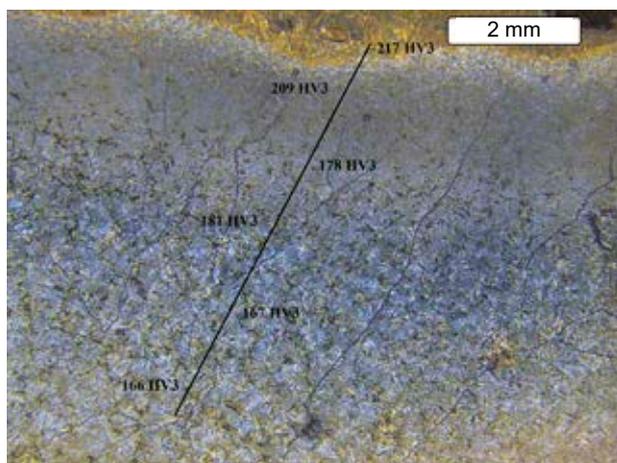
In the location of the appearance of the padding, a hardness distribution was performed using the Vickers method (HV3), running from the surface towards the core, according to the line shown in Figure 12, on which the obtained hardness results were taken. On the basis of the performed hardness measurements, hardening of the material in the location of the padding was found; this was not especially severe, and confirms the appearance of the padding.

Figure 12. A stereoscopic image of the microstructure in an etched state. The line indicates the course of the performed hardness distribution (HV3) involving the padding, the heat-affected zone and the casting core
